PROPOSED (PROPUESTO)

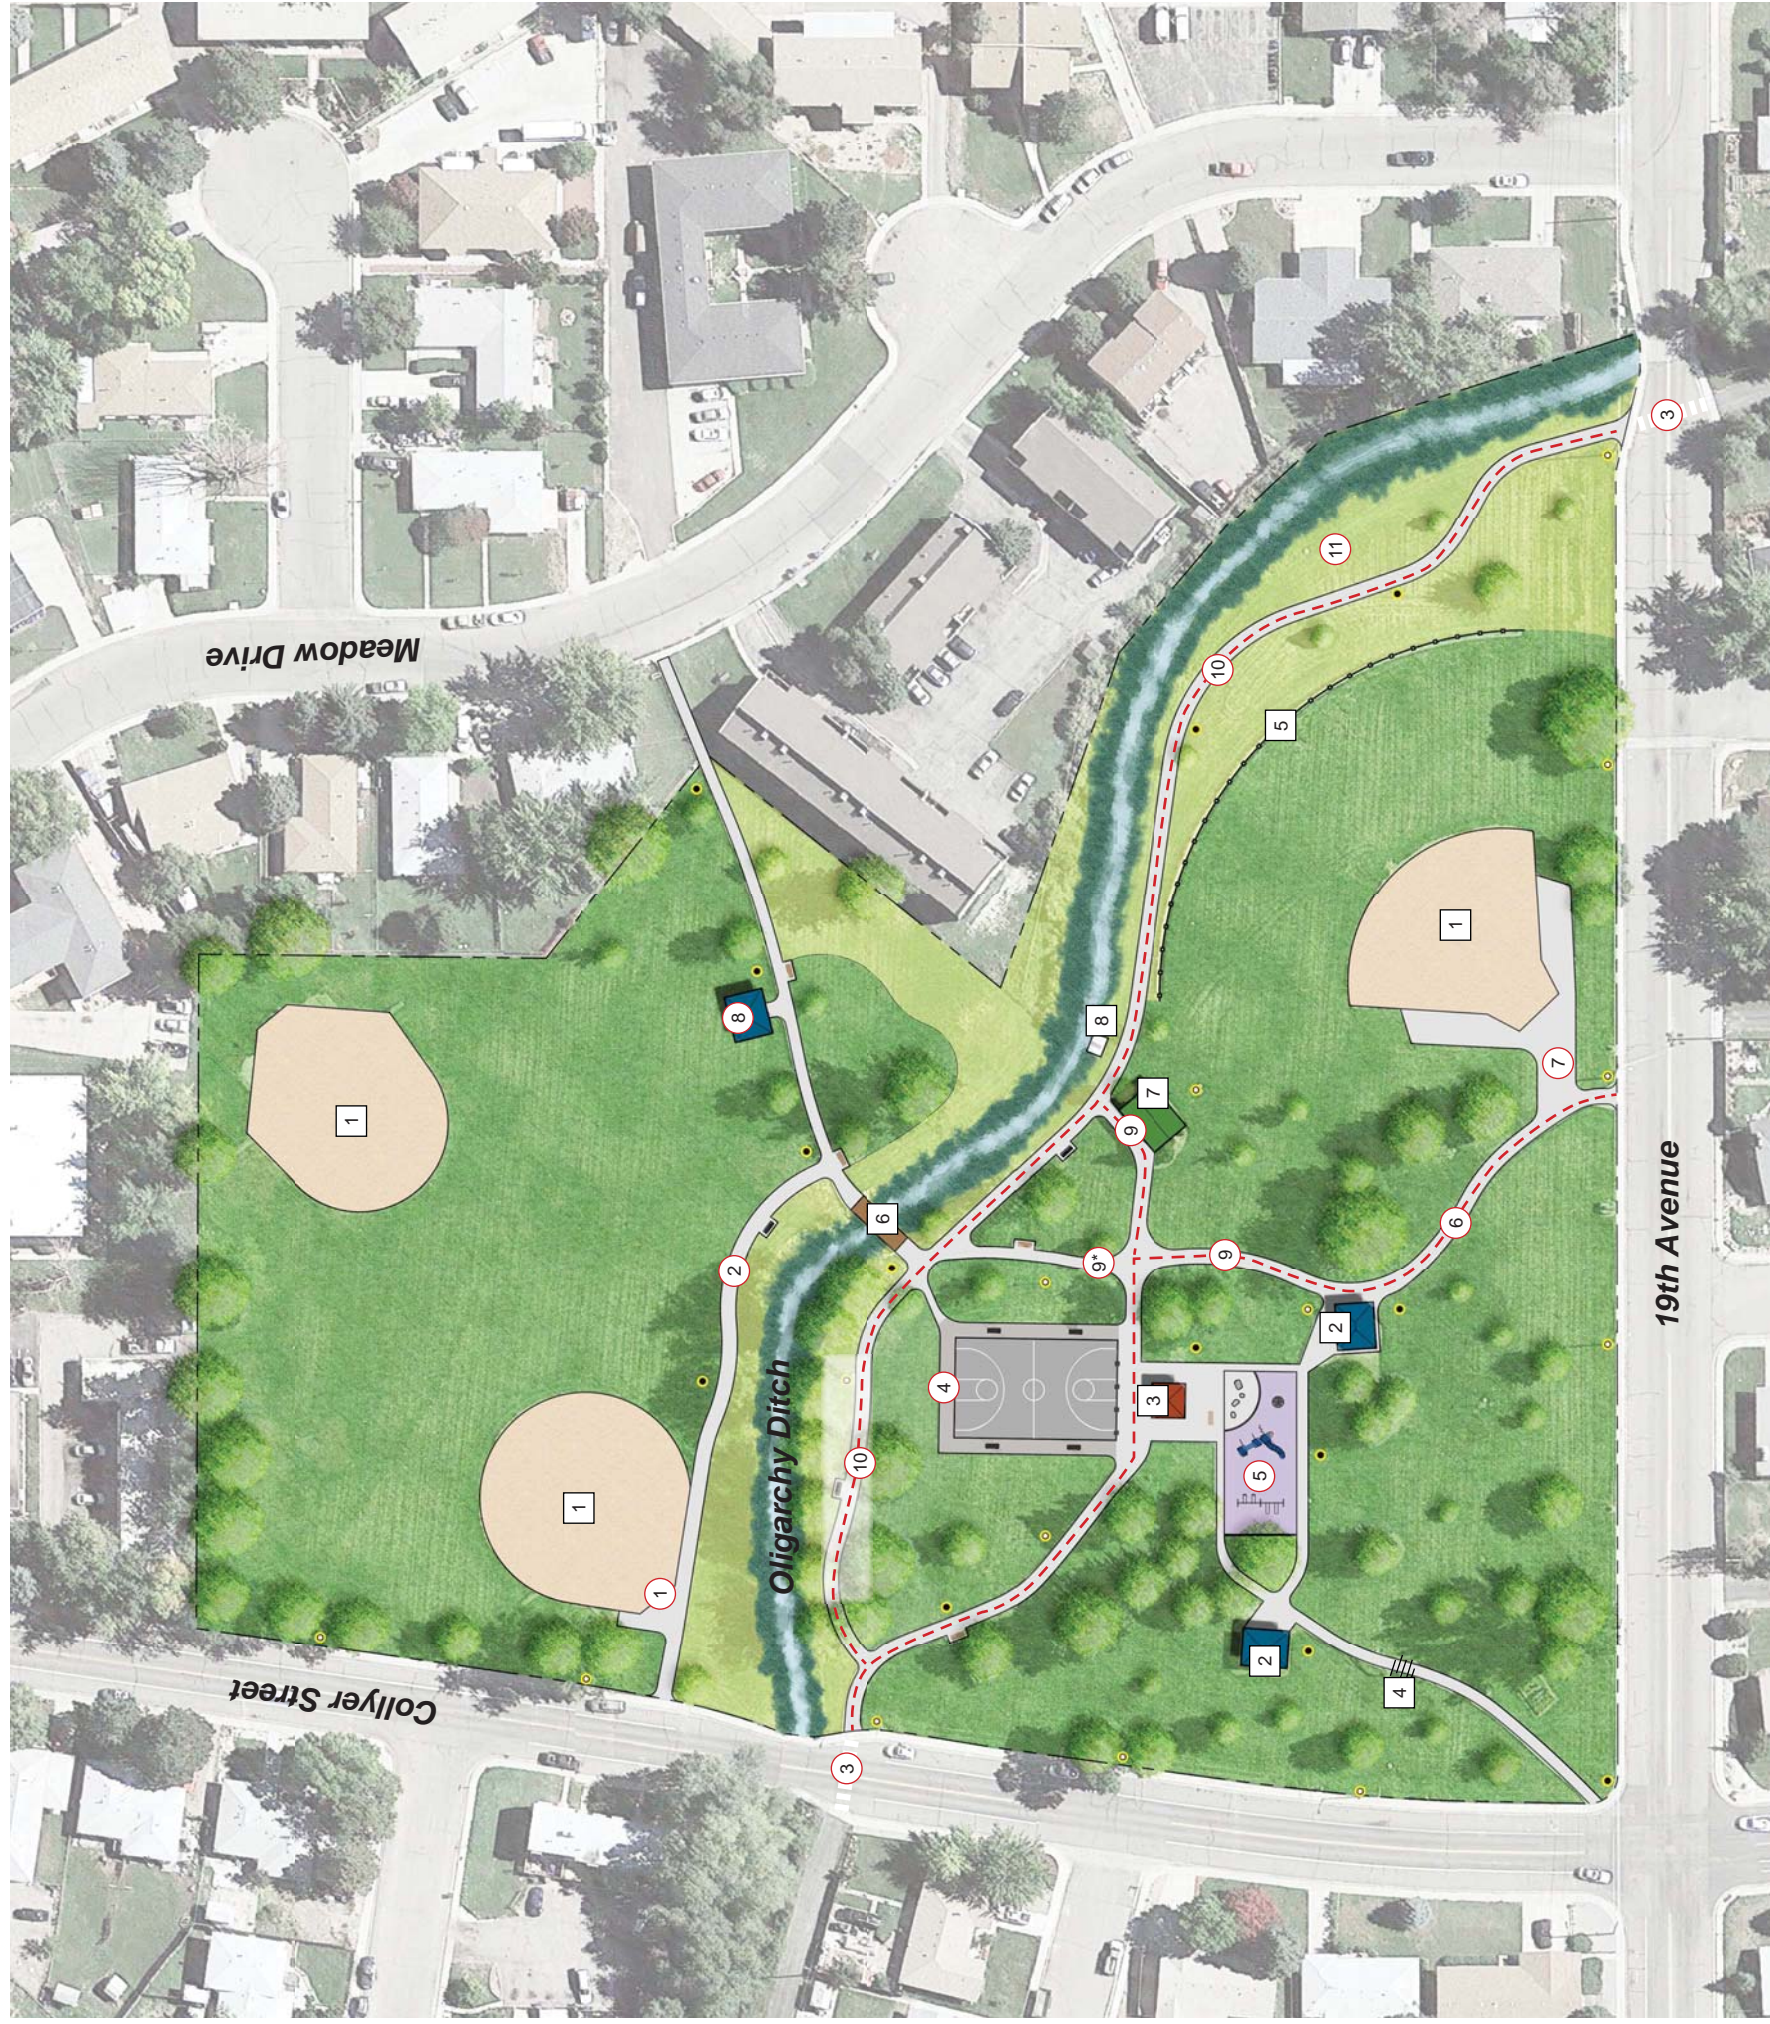
- 1 New concrete ADA access to ballfield
Conexión ADA
- 2 New 8' concrete connector trail
Camino conectado de ADA de 8' de ancho
- 3 New mid-block crosswalk (to be coordinated with expansion of the Oligarchy Greenway Trail)
Paso de peatones

- 4 Basketball court edge improvements: Remove existing 10' fence; add 4' fence/rail at grade break on south edge of court, install 4 backless benches and 8' colored concrete apron around court to provide safe buffer
Mejoras en el cancha de baloncesto

- 5 Renovate play area in same location (includes play surfacing, equipment, walkways, etc.)
Renovar la zona de juegos en el mismo lugar
- 6 Replace existing walk to accommodate service vehicles - new walk to be 8' minimum concrete paving
Reemplazar el paseo existente para permitir acceso de los vehículos de servicio

- 7 New ADA connection, concrete staging/spectator area, and ADA access to dugouts
Conexión ADA - escenario de cemento y área de espectadores
- 8 New 20'x24' shelter
Refugio de la sombra, 20'x24'

- 9 New 8' concrete walk (maintenance access to utility building and pedestrian circulation)
*Realignment of existing walk
Camino de cemento

- 10 New concrete greenway trail along Oligarchy Ditch
Rastro via verde a lo largo de la zanja
- 11 Convert to low water vegetation area (typ.)
Note: Adjust irrigation to ensure tree viability
Área de vegetación natural

- 1 Existing ballfield (A grass multi-use field could be considered in place of the existing northeast ballfield if alternative ballfield facilities are developed elsewhere in the City)
Cancha de pelota existente
- 2 Existing shelter
Refugio existente
- 3 Existing restroom
Baño existente
- 4 Existing artwork
Ilustración existente
- 5 Existing ballfield fence
Cerca del campo de béisbol existente
- 6 Existing bridge
Puente existente
- 7 Existing utility building
Edificio de utilidad existente
- 8 Existing drainage inlet
Entrada de drenaje existente
